Draft Preliminary HMA Report

Rancho Viejo Solar Utility BESS

August 13, 2024
Revision A

Prepared by: Coffman Engineers, Inc.

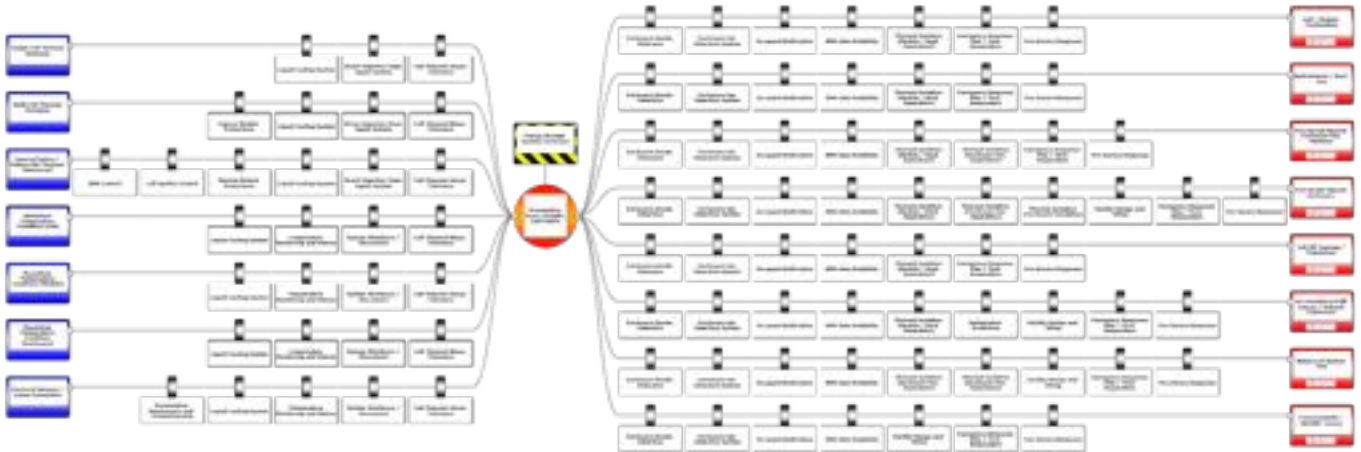
Figure 6 – Thermal Runaway and Mechanical Failure Bow Tie Diagram

The fault condition analysis below uses the four bow tie diagrams shown below as Figure 6 through Figure 9 for evaluation of the failure modes against the acceptance criteria identified in Table 2. See Appendix E for enlarged versions of the bow tie diagrams.

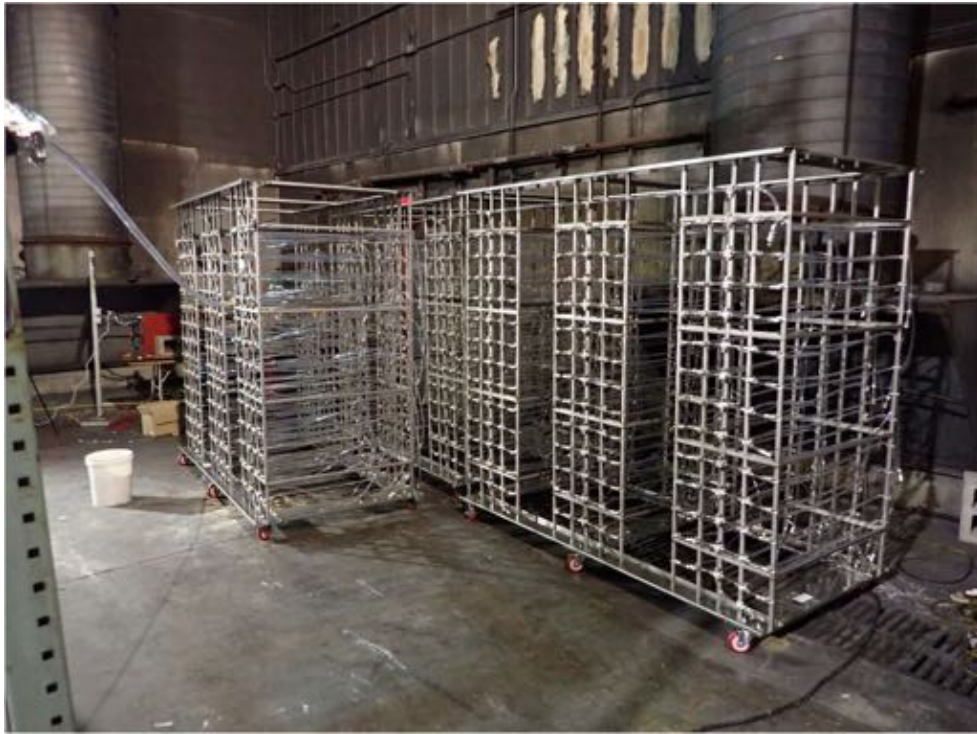
Figure B7 – Dummy Racks with NOVEC Piping⁶

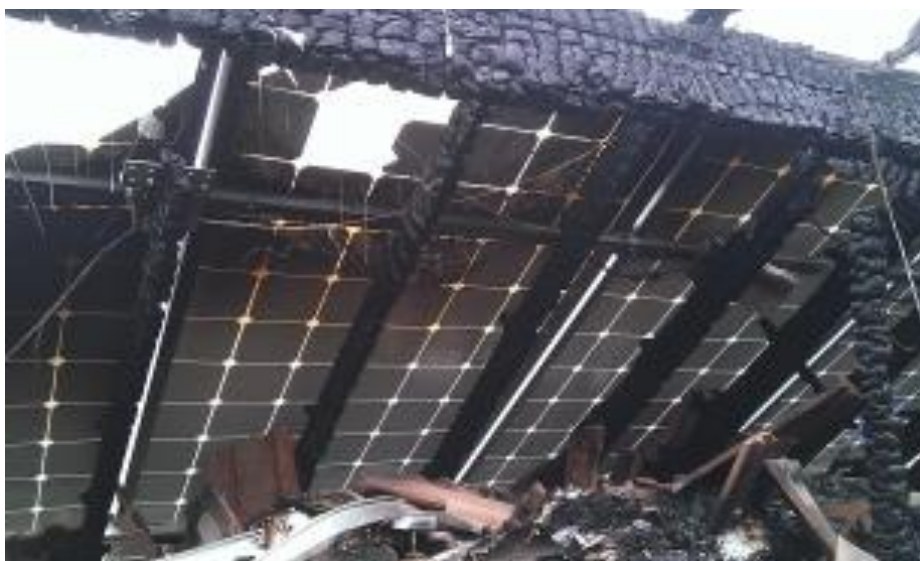
Figure 3 shows an example of a domestic roof, with a PV system fitted, destroyed by fire.

Figure 3: Example burnt-out roof with parts of the PV system intact.

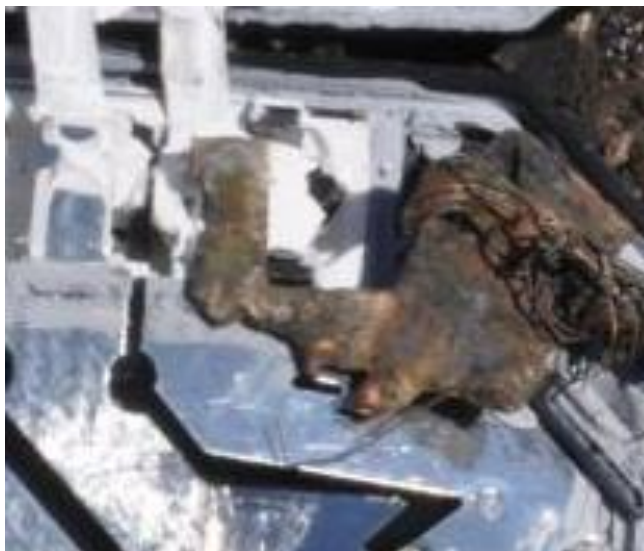
Where PV modules are the source of fire, there may be evidence of arcing within the remains of one or more of the modules – an example can be seen in Figure 14.

Figure 14: Damaged part of a PV module junction box laid over an identical undamaged component, showing where material has been ablated through arcing.

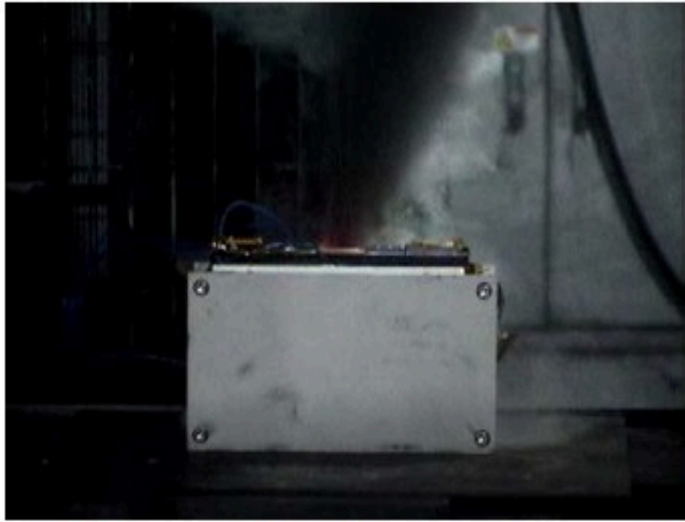
Cell 1 - Immediately before thermal runaway*
(00:43:54)

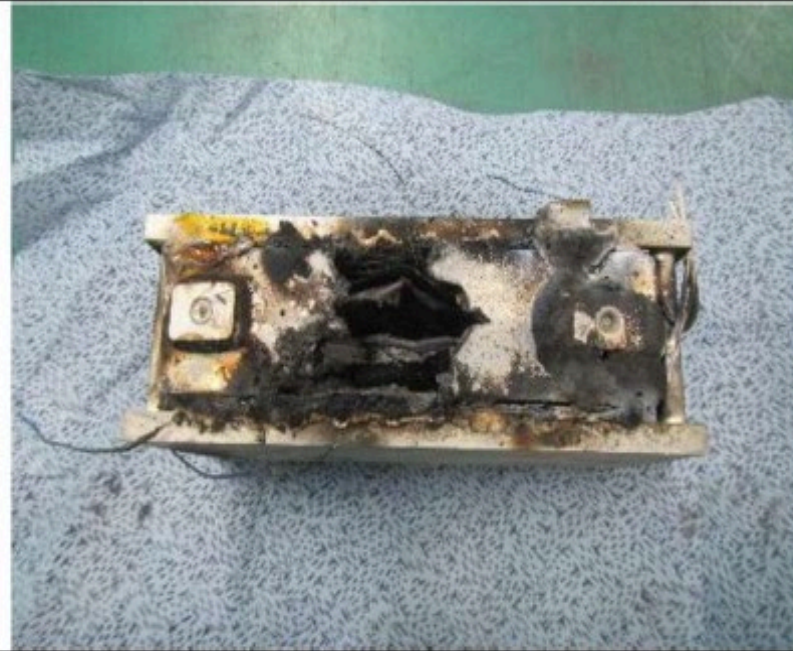
Cell 1 - After the end of test
